PENDLETON, INDIANA:

An Architectural Study
and
Handbook for Active Revitalization

Prepared by
The Graduate Program in Historic Preservation
Ball State University
Muncie, Indiana
Fall 1995

ARCH 506 - PRESERVATION DESIGN STUDIO
FALL SEMESTER 1995

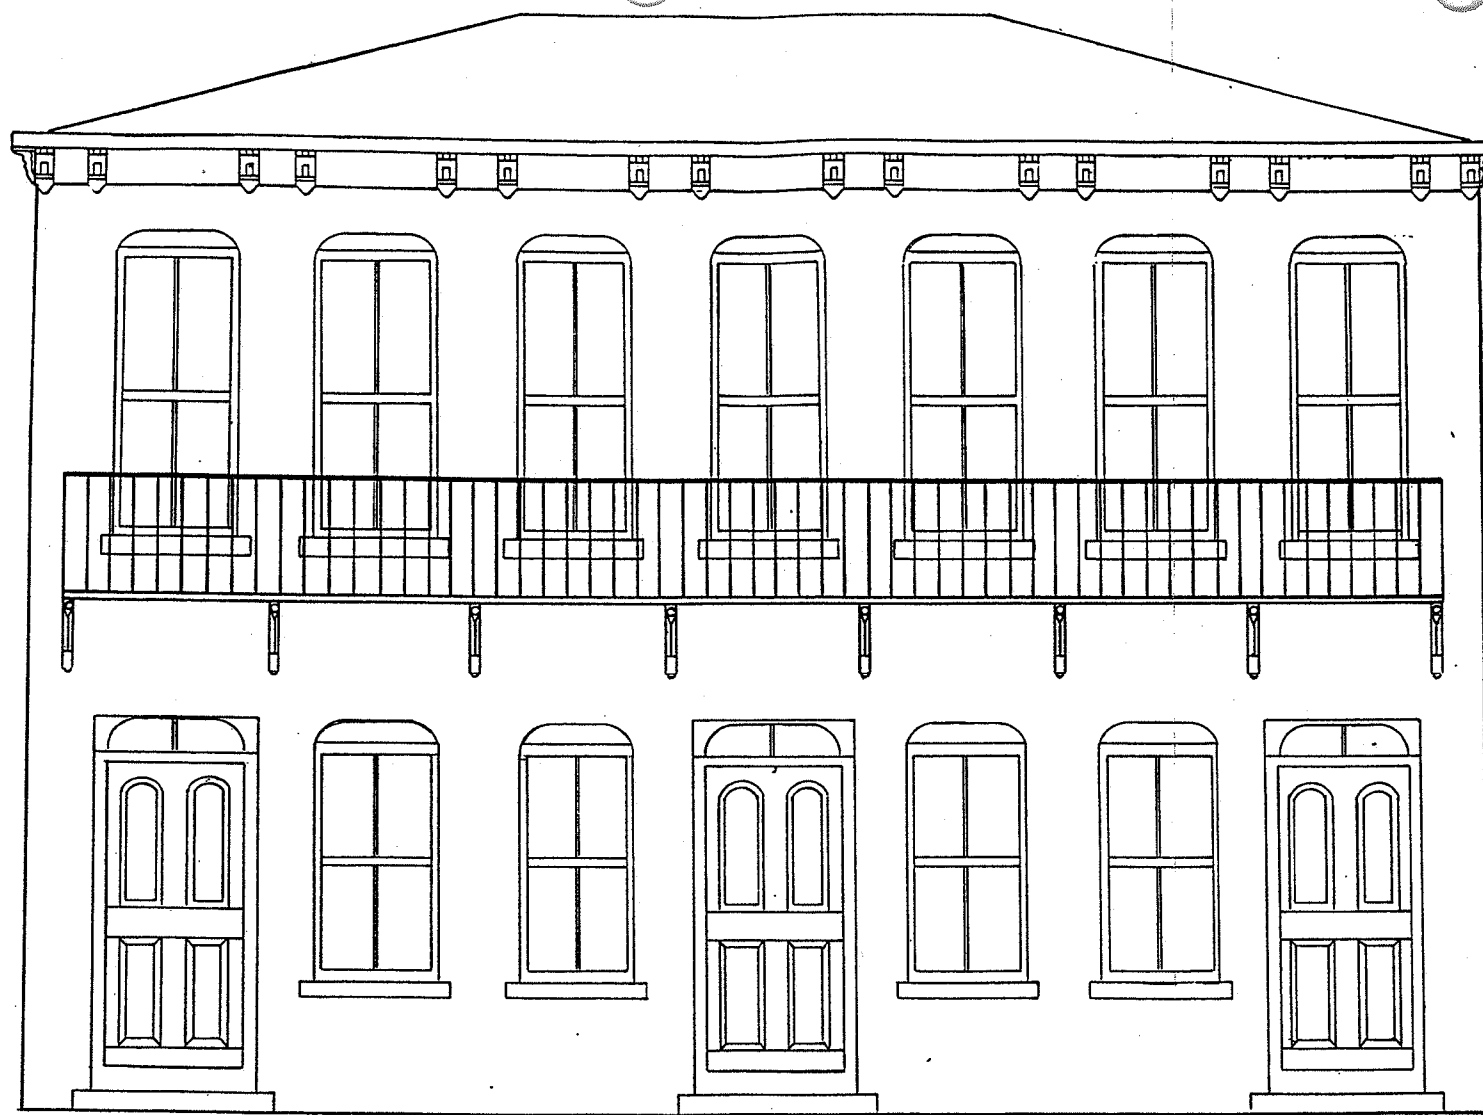
Figure 5: 101 W. State Street Full Rehabilitation, c. 1875.

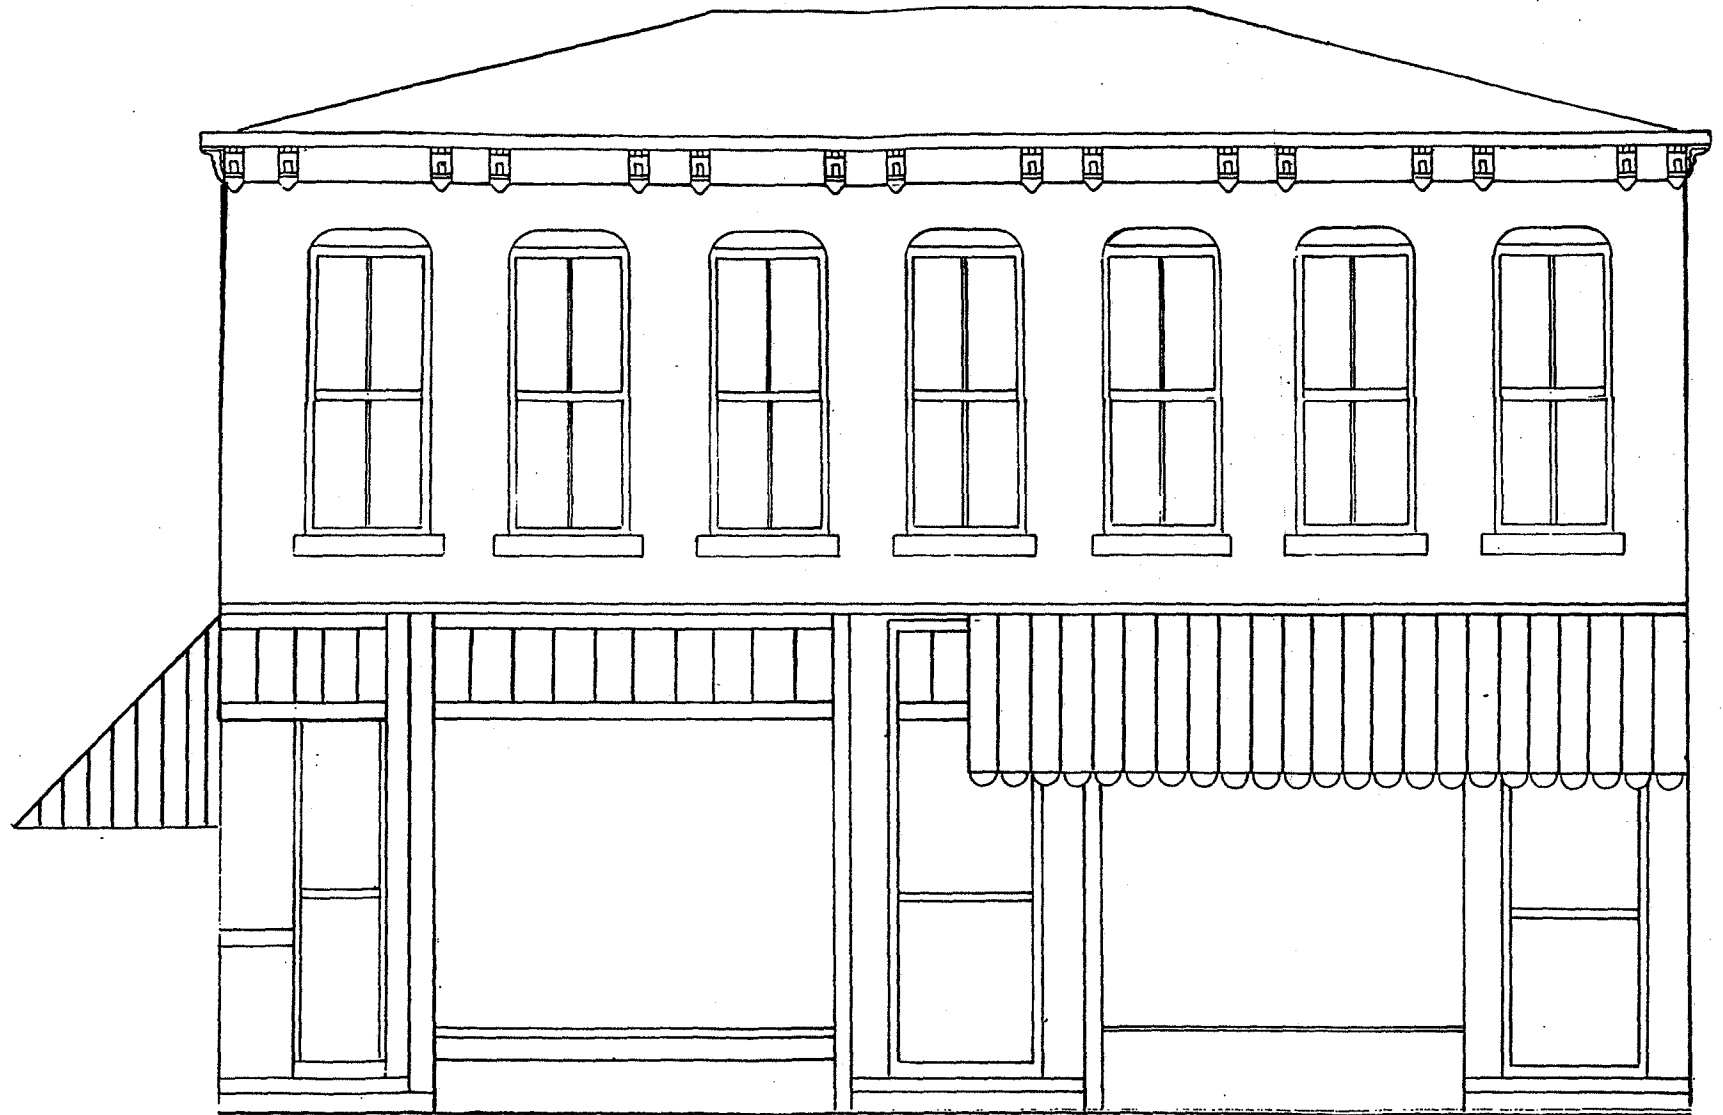
Fig. 6: 101 W. State Street Full Rehabilitation, c. 1920.

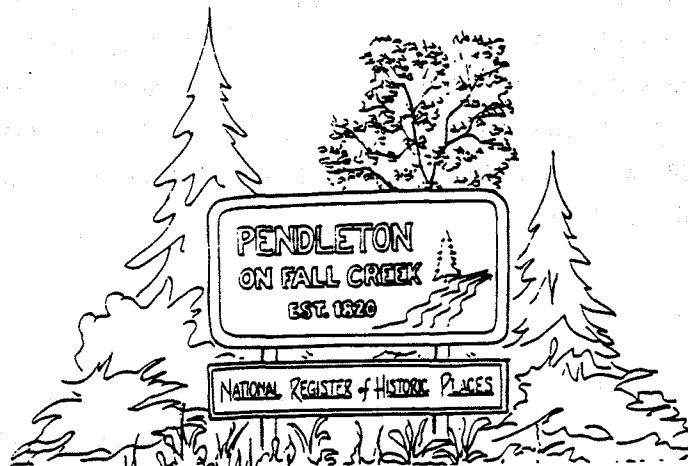
Fig. 1: Major Gateway: Proposed appearance showing repainted sign and landscaping.

A further recommendation for gateway improvement would involve landscaping a small area immediately around the two signs. This could include planting small trees, such as pine or fir trees, behind the signs and decorative bushes and shrubs to the sides. The area immediately in front of the signs could be used for the planting of decorative bedding plants and seasonal flowers. Brightly colored plants and flowers will help to draw more attention to the gateway signs. Painting and landscaping to enhance and beautify the gateways will convey to the visitor a sense of local pride in the community, and further heighten the feeling that one is entering into a "special place" (Fig. 1).

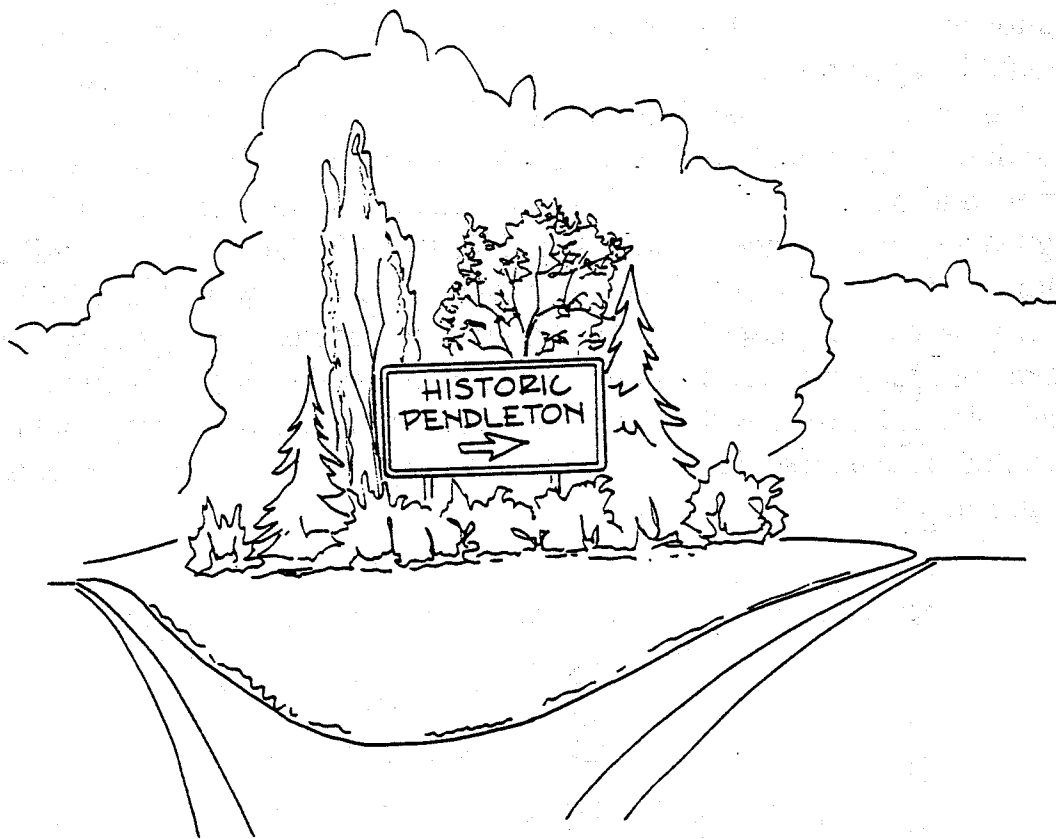
Fig. 2: Minor Gateway: Proposed appearance showing new sign and landscaping.

of entry would be aimed at traffic heading south on Highway 67. The southern gateway is located where Old State Road 9 (South Pendleton Avenue) rejoins Highway 67 south of town, and would be aimed at traffic heading north on Highway 67. The stretches of road from these two points to the center of town are very picturesque drives, and could be utilized as alternate entry routes into Pendleton (Fig. 2).

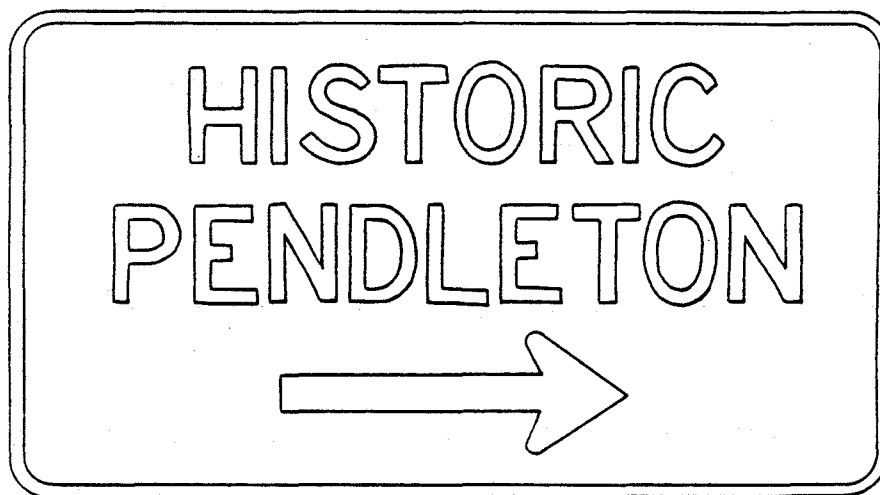
Fig. 3: Gateway Feeder: This sign advertises the historic district and directs traffic towards the major gateway.

These two proposed gateways should feature signage which invites the visitor into town. Both sites are along busy Highway 67, so the signage should be appropriate to the highway location. The signs should be made according to state specifications for highway usage. This means an aluminum sign with a reflective green background and reflective white letters and border. The text of the sign must be limited for readability at highway speeds. Suggested text is "HISTORIC PENDLETON ... 1 MILE" with an arrow pointing the direction to town. Use of the word "historic" will alert tourists and passersby to the significance of Pendleton, and will tell them that they are not passing "just another small town." If funds are available, and there is sufficient civic interest, limited landscaping could be installed around these signs, similar to that suggested for the major gateways (Fig. 3 and 4).

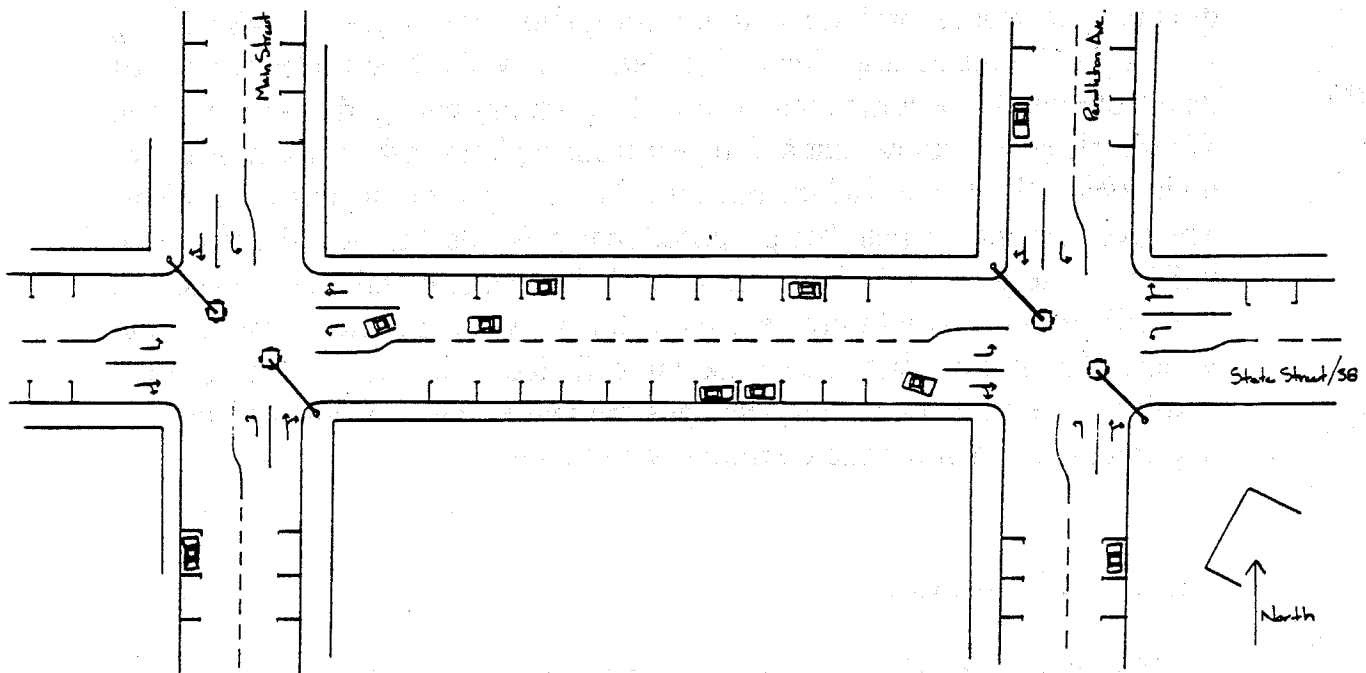
Fig. 8: Downtown parking and traffic patterns.

The second change that is recommended for State Street is the addition of left turn lanes at the two major intersections at Main Street and Pendleton Avenue. These turn lanes are necessary due to the traffic back up that often occurs when vehicles are unable to turn left because of oncoming traffic. It is estimated that adding these turn lanes at the two intersections will result in a minor loss of on-street parking spaces on Pendleton Avenue, State Street, and Main Street. This loss will be offset by the improved traffic flow and pedestrian safety. Installation of these turn lanes would require only restriping the road (Fig. 8).

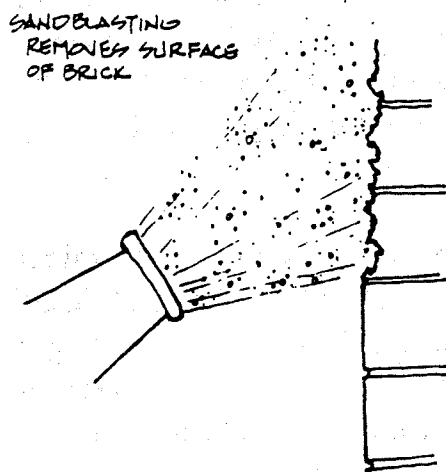
Fig. 1: Sandblasting damage to masonry surfaces.

- Sandblasting, high pressure water blasting (over 600 psi), grinding, and harsh chemicals should never be considered as options for cleaning masonry. Such activity will weaken or damage masonry materials, and will actually remove the surface, known as the "fireskin," of historic bricks. Water can also be introduced into structures through such activity.

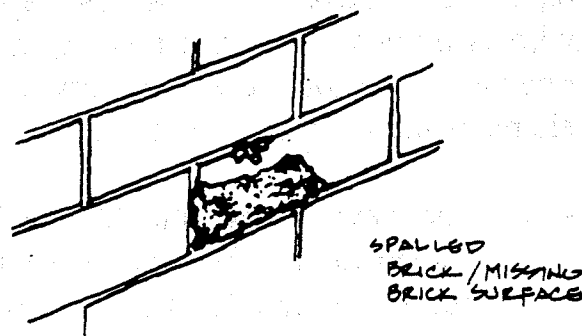
Fig. 2: Spalled/missing brick surface.

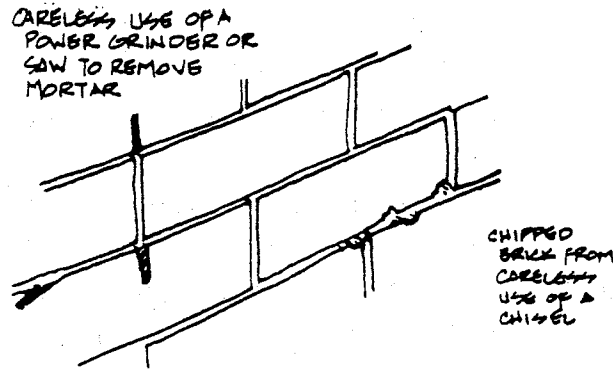
Fig. 3: Damaged brick from inappropriate mortar removal techniques.

- Avoid using power grinders or other power tools to remove damaged or failed mortar. Errors in handling the machinery can irrevocably damage historic materials.

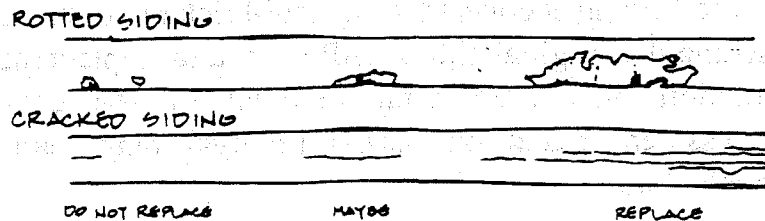
Fig. 4: Rotted and cracked siding.

- Siding should be primed and painted after being scraped of all loose paint and subsequently washed.
- Replacement of original siding is generally justified only by documented problems with the material's structural condition. Aesthetic reasons generally do not justify replacement. As a rule, the following are conditions which generally do justify replacement:
 - Badly rotten wood.
 - Boards with splits (especially multiple splits) that cannot reasonably be repaired.
 - Burned wood.
 - Missing wood.

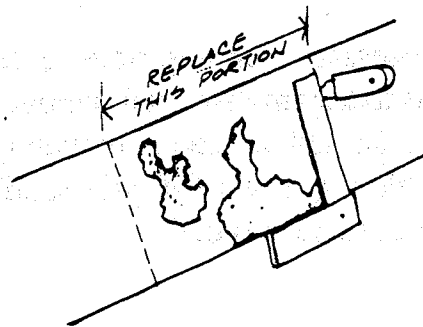
Fig. 5: Damaged area of wood siding showing portion needing replacement.

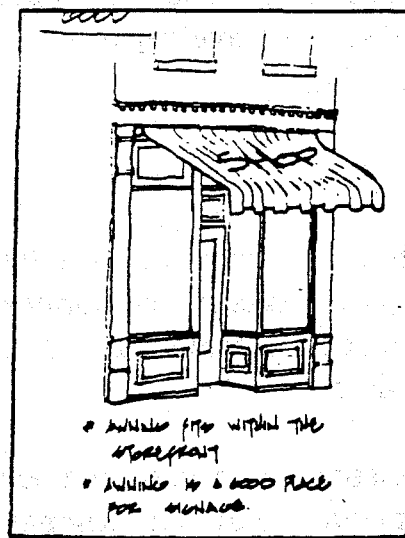
Fig. 9: Examples of "Preferred" and "Not Recommended" awning treatments.

- Awnings whose shape detracts from the proportions and/or architectural style of the building.
- Awnings or canopies that are intrusive on the streetscape.

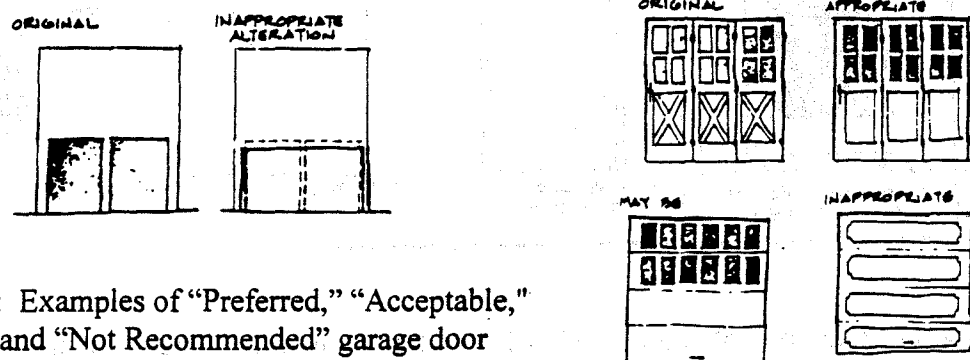
Fig. 10: Examples of "Preferred," "Acceptable," and "Not Recommended" garage door treatments.

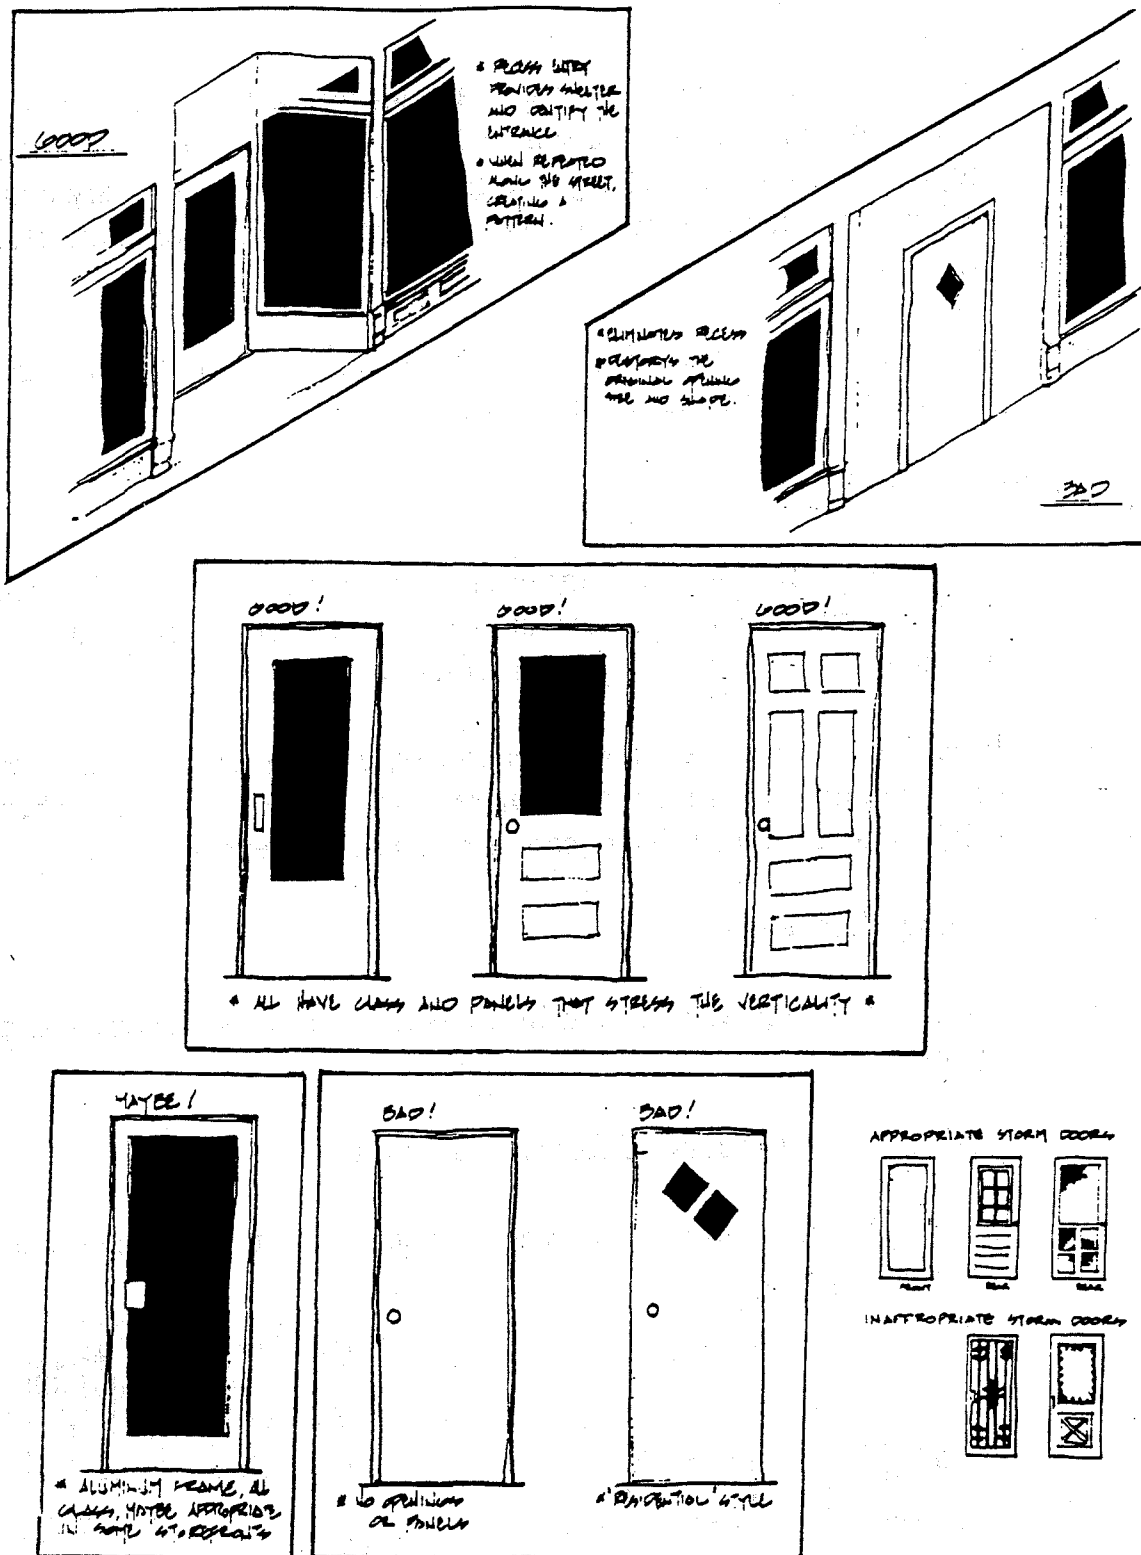
Fig. 11: Examples of "Preferred" and "Not Recommended" exterior door and entrance treatments.

- Introducing new door openings or changes in existing openings such as elimination, enclosure, relocation, reduction, or enlargement that will alter the scale and proportion of the building.
- Installing door features of incompatible style or material such as vinyl or aluminum that requires total removal of existing units when original doors and hardware can be restored and reused.
- Sliding glass doors.
- Discarding original door hardware which could be repaired and retained.
- Residential style doors on commercial buildings.
- Door styles or detailing that create a false historical appearance and are inappropriate.

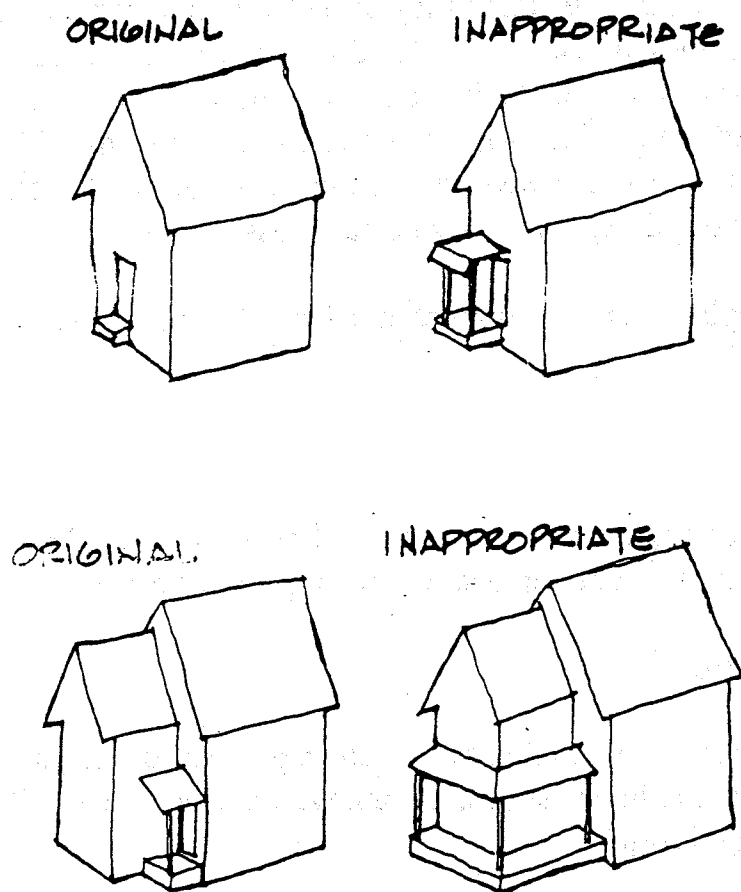
Fig. 12: Examples of "Not Recommended" porch treatments.

- Alterations or removal of historic porches, steps, and details which define the character, style, construction, and historical development of porch or property.
- Replacement of original wood porch floors with concrete.
- Locating new porches where they were never present, especially on highly-visible facades.
- Introducing elements which represent different construction periods, methods, styles, or innovations as replacements or additions to porches, creating a false historical appearance that is not appropriate.
- The removal of porches not original to the building but which contribute to the character of the property, or have developed historical or architectural significance in their own right.

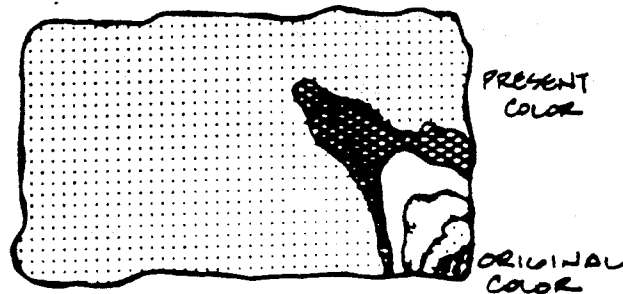
Fig. 15: Example of paint chip analysis.

- Remove all loose paint and clean the surface before repainting. It is not necessary to remove all old paint if it is firmly affixed to the surface.
- Paint colors are basically a personal preference. They are reversible, have no permanent effect, and have usually undergone many changes over the lifetime of the building. There are two general approaches which are appropriate for choosing a color scheme.
 - Identify the original paint colors through research or paint analysis, and repaint with matching colors. Previous paint colors can be uncovered by scraping through the accumulated paint layers with a knife, analyzing the paint in the laboratory, or finding hidden areas which were never repainted.

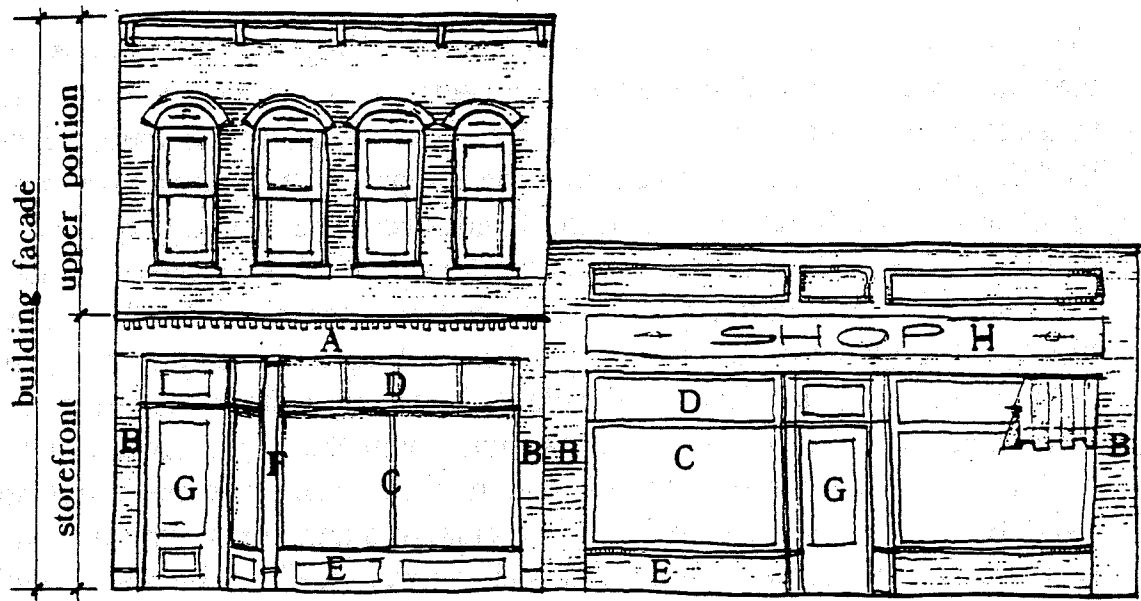
Fig. 19: Typical late-nineteenth-century storefront elements.

The typical late-nineteenth and early-twentieth century storefront had many standard features. The main entrance to the business was usually centered in the storefront and featured either a single- or double-door. The entrance was often recessed from the front plane of the facade of the building, which kept the door from accidentally opening into pedestrians on the sidewalk and also provided some shelter for the entrance. It was also fairly common for the entrance to be located at one side of the storefront. Frequently, a second door was located at one side, and opened onto a stairway that led to the second floor of the building. The windows usually ran the full width of the storefront, in order to maximize the display area and the amount of light let into the ground floor. These windows usually consisted of the largest panes of glass that could be economically produced at the time that the building was constructed. Below these windows were rectangular kickpanels of wood or sometimes pressed metal. Above the display windows were usually transoms. These often feature plate glass panels or small square pieces of Prism Glass, a type of glass tile specially designed to throw light deep into the interior of a building. Thin vertical structural members separated windows and doors, and defined the edges of the storefront. These members were usually cast iron, wood, or sometimes masonry. Above the transoms, an iron beam spanned the top of storefront, bearing the weight of the upper facade and resting on the vertical structural members. This basic storefront design remained relatively unchanged until the 1920's and 1930's.

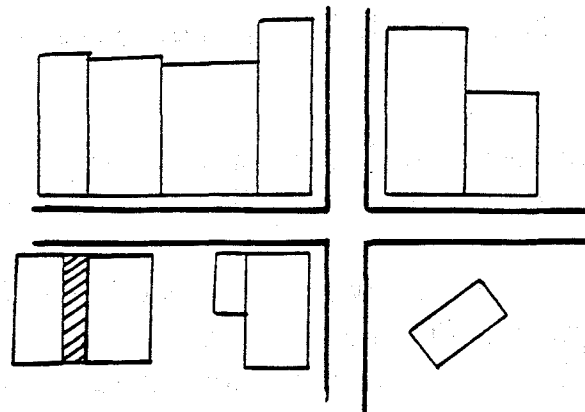
Fig. 24: Developed site, an addition to an existing building. Existing building is used in determining primary design of the addition.

Site 1 can be defined as a “Developed Site,” or a site upon which an historic primary structure exists. New construction in this case usually involves an addition to the historic building. New construction in this situation must use the existing historic structure as its most important context upon which to base the contemporary design. The addition should not overpower the historic facility, but should provide a tasteful continuation of the aesthetics already established.

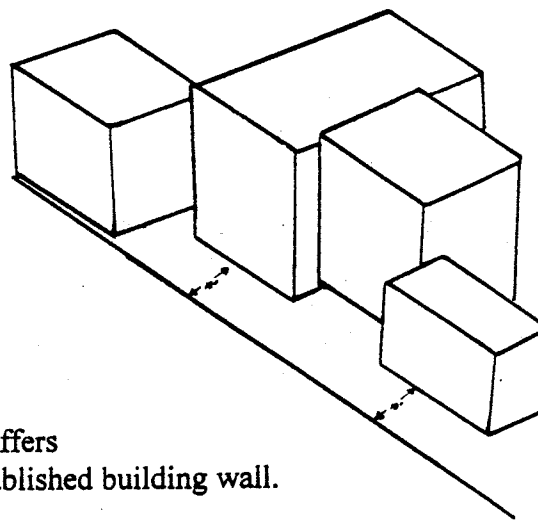
Fig. 27: Pendleton's standard historic commercial setback is 10 feet. New construction that differs from this standard breaks the established building wall.

- New construction that breaks the historic "building wall" or "curtain" by either being too close to the street or too far removed. In Pendleton this is any deviation from the 10 feet historic setback.

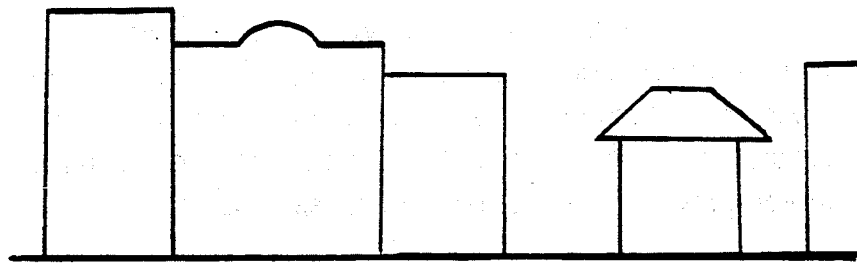
Fig. 29: Preferred, maintaining the contiguous building wall.

- The creation of large open spaces or "missing teeth" should be avoided. New construction that creates these voids destroys the traditional pattern and rhythm of the street.

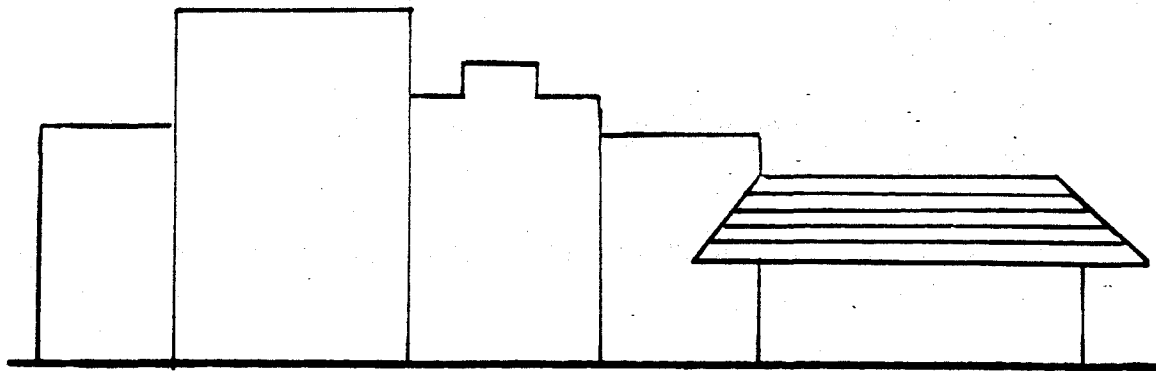
Fig. 30: Preferred, new construction outlines should reflect historic outlines.

- Roof shapes which create historically uncharacteristic shapes, slopes and patterns.

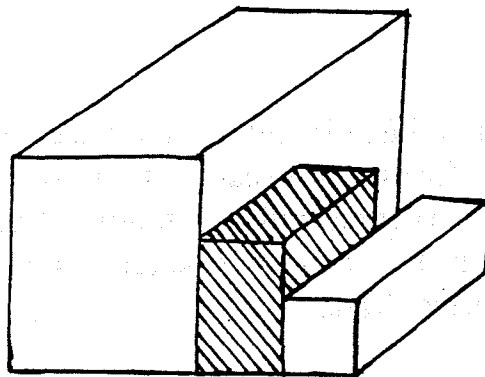
Fig. 31: Preferred mass--between largest and smallest masses.

- Avoid the construction of a building that exceeds either the height or width of the largest buildings in the commercial area.

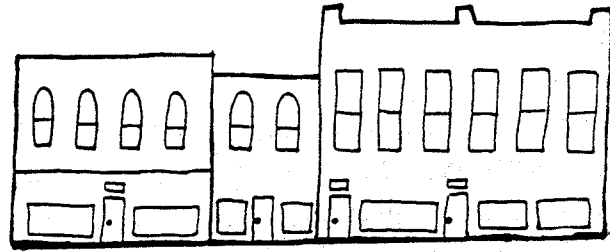
Fig. 32: Preferred fenestration according to historic pattern.

- Avoid window openings which conflict with the proportions and directionality of those typically found on surrounding historic buildings.
- Avoid window sash configurations which conflict with those on surrounding historic buildings.

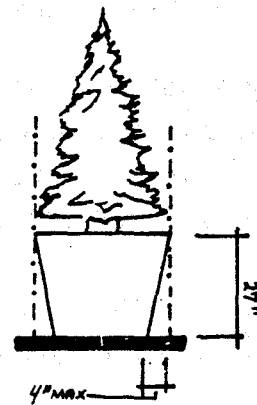
Fig. 49: Proposed planter showing height and proportions.

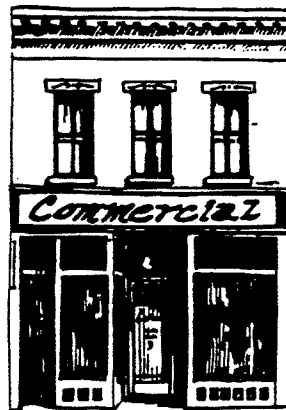
Fig. 51: Example of a signboard.

Signboards, historically, were very common types of commercial signage. Historic photographs of Pendleton show the widespread use of this type of signage in the downtown area. These long, narrow signs are located directly above the storefront and serve as a transition between first-floor retail uses and residential uses above.

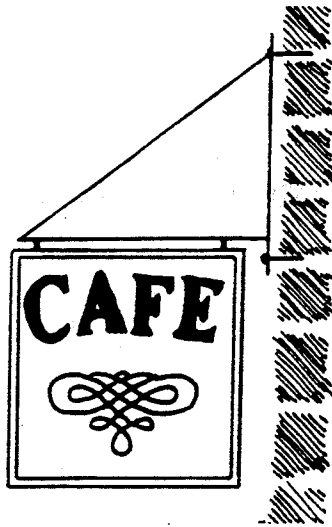
Fig. 52: Example of an overhanging sign.

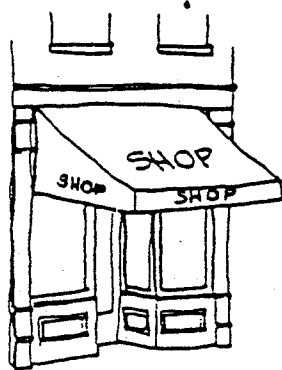
Fig. 53: Example of an awning sign.

Awnings, both historic and contemporary, are often used to shade the interiors of storefronts and protect pedestrians from the weather. These awnings also provide another opportunity for signage location. Signage can either be applied to the sloping surface, side panels, or valance of the awning.

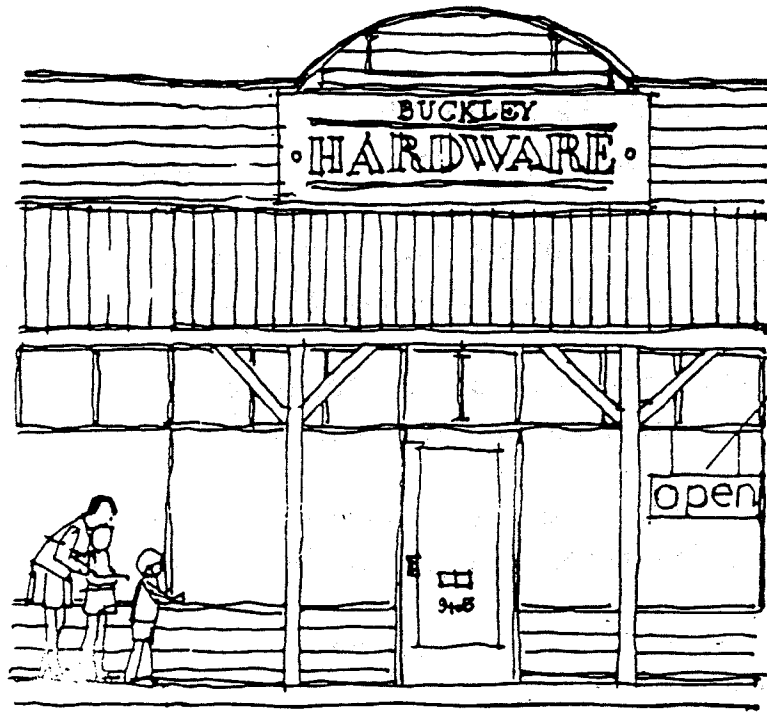
Fig. 55: Example of appropriately designed sign.

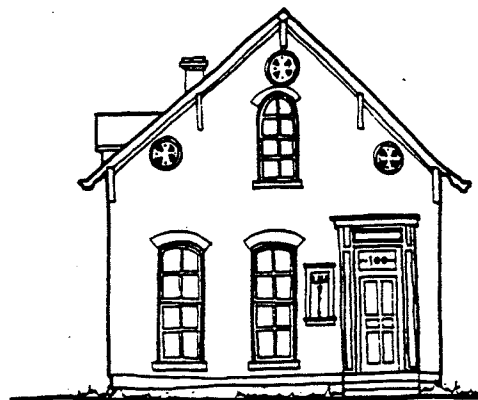
Fig. 2: New appropriate use of c. 1863 structure as small scale commercial.

- a property shall be used for its historic purpose or be placed in a new use that requires minimal change to the defining characteristics of the building and its site and environment. (See fig. 1 and 2)

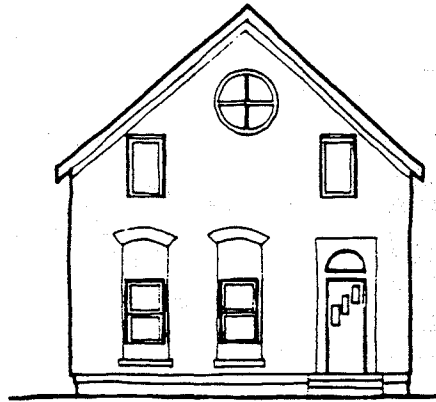
Fig. 3: Inappropriate alterations and removal of historic material from c. 1863 structure.

- The historic character of a property shall be retained and preserved. The removal of historic materials or alteration of features and spaces that characterize a property shall be avoided. (See fig. 3)
- Each property shall be recognized as a physical record of its time, place, and use. Changes that create a false sense of historical development, such as adding conjectural features or architectural elements from other buildings shall not be undertaken (See fig. 4).

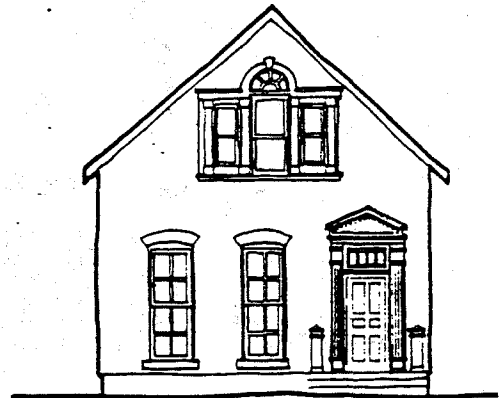
Fig. 4: Inappropriate changes creating false sense of from history.

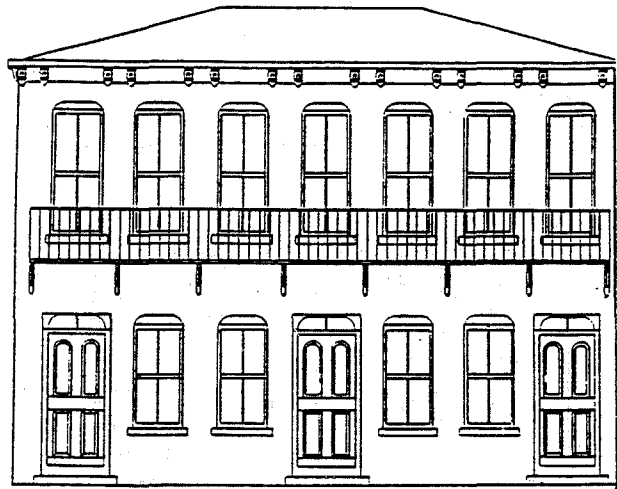
1840-1880, the Italianate is often referred to as the “bracketed style” due to the style defining bracketed cornice. Often Italianate buildings have detailed round-arched windows.

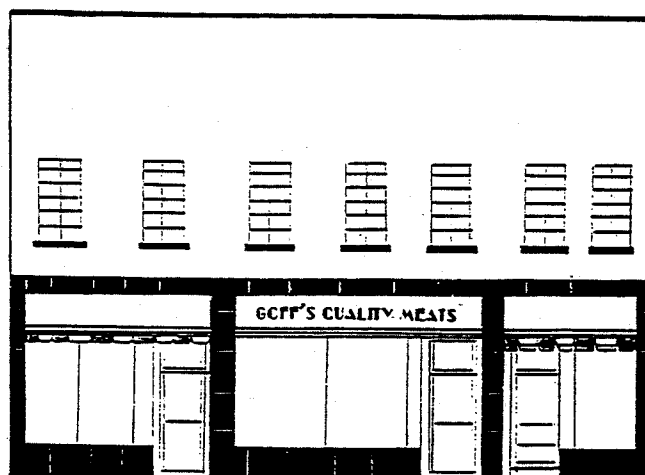
Art Moderne

1935-1950, this streamlined style is characterized by minimal detail, casement windows, and often simple banding in a contrasting color or texture.
